Navajo Abandoned Uranium Mine

Site Screen Report

Mesa IV, East Side AUM Site

March 2010

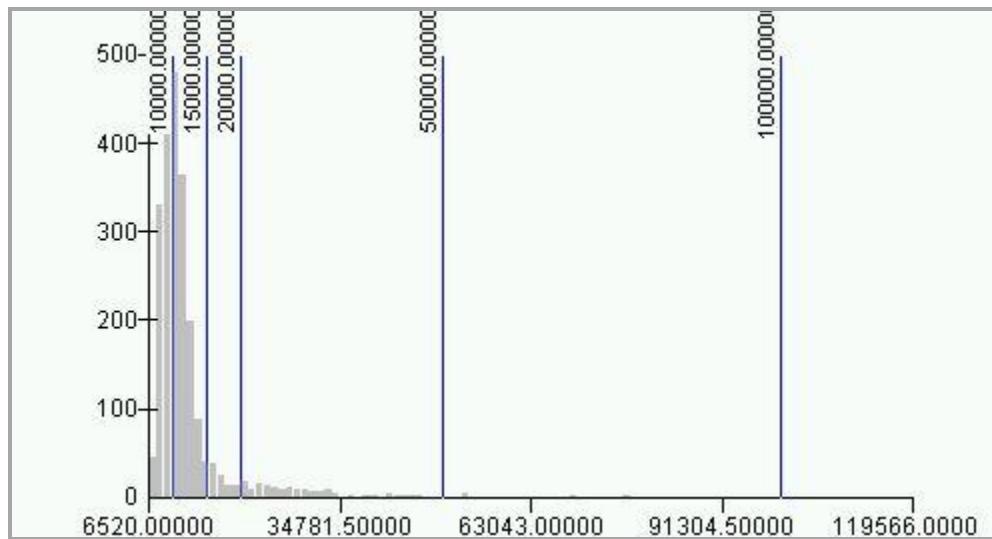
The following chart and statistics were generated by ESRI ArcGIS 9.3.1, and show the general distribution of the site gamma radiation measurements. The horizontal X axis represents the gamma radiation reading levels in cpm (lowest levels to the left). The vertical Y axis represents the frequency of each gamma radiation level.

Count:	2275
Minimum:	6520.00000
Maximum:	119566.00000
Sum:	28747015.00000
Mean:	12636.05055
Median:	10637.00000
Standard Deviation:	8483.47349

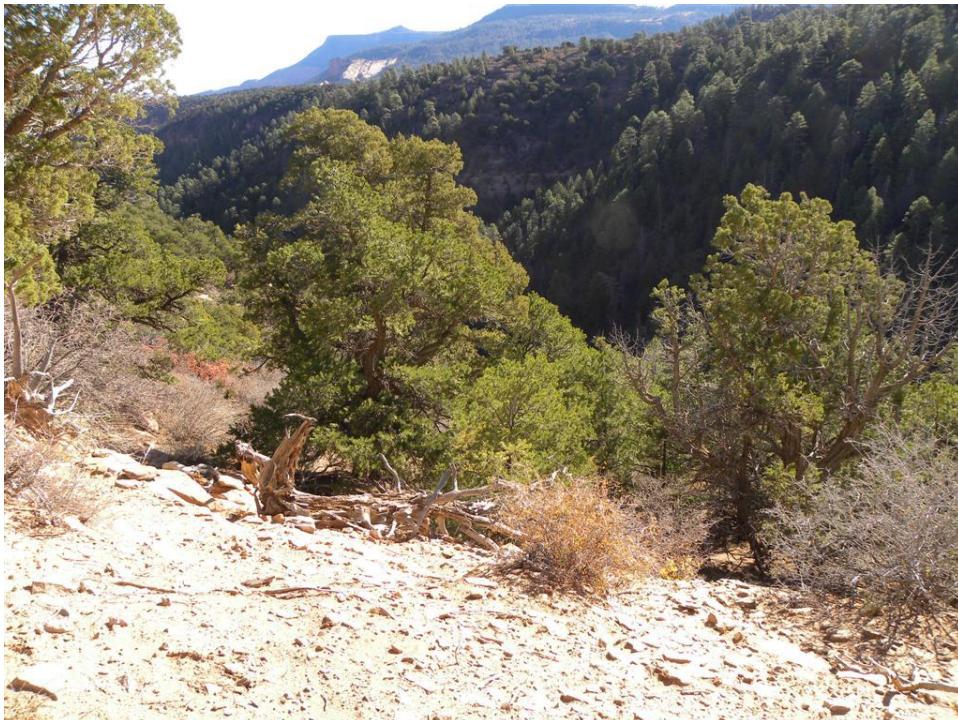
Photo 1. Mine site

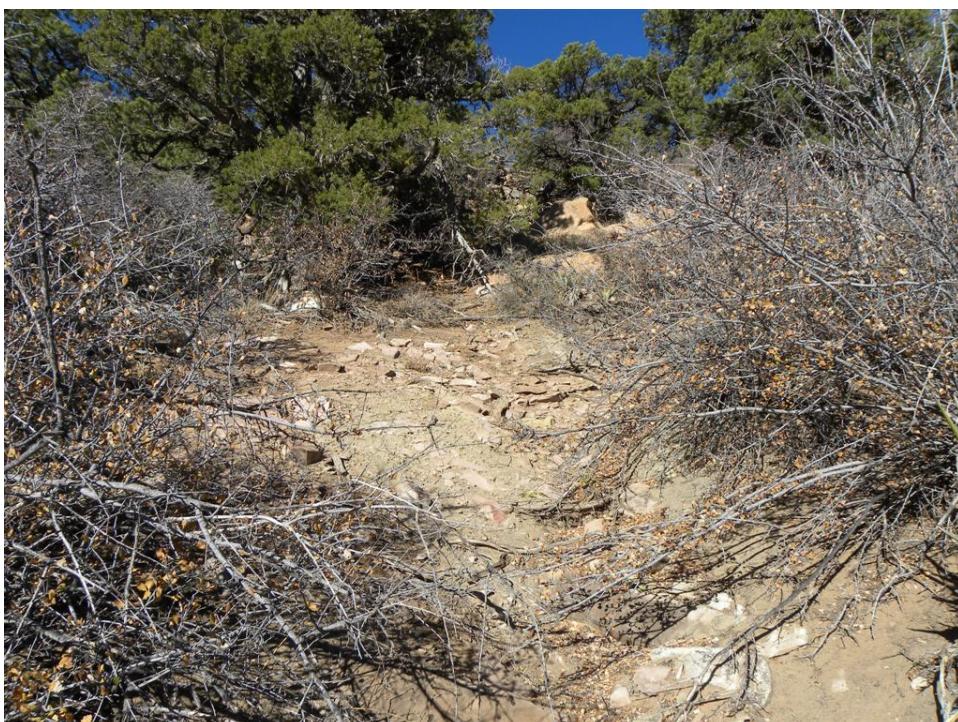
Photo 2. Mine site up slope

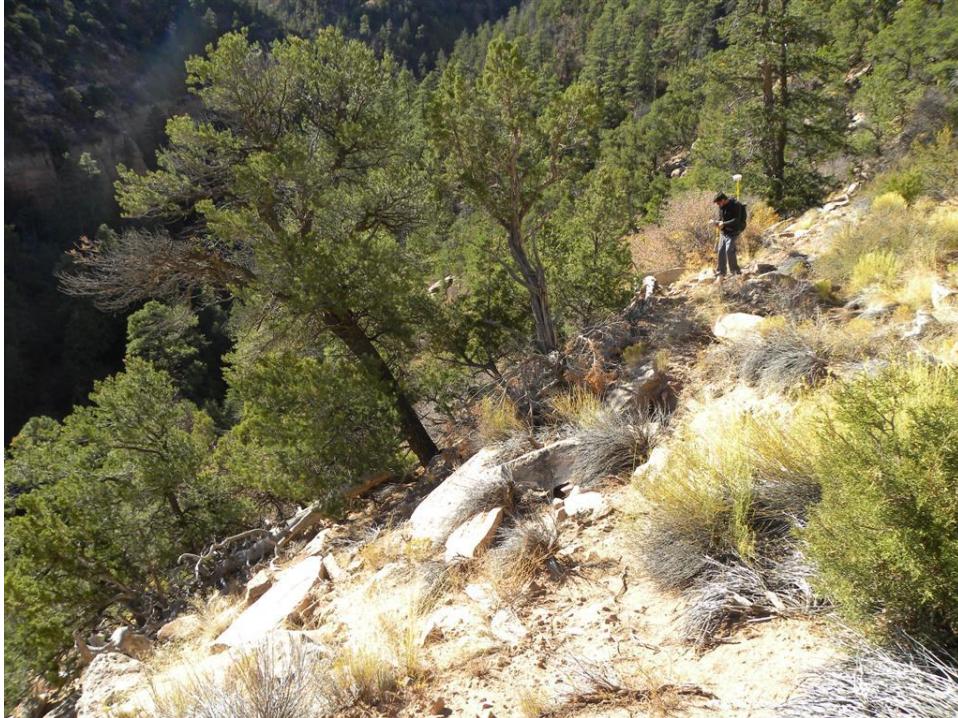
Photo 3. Mine site down slope

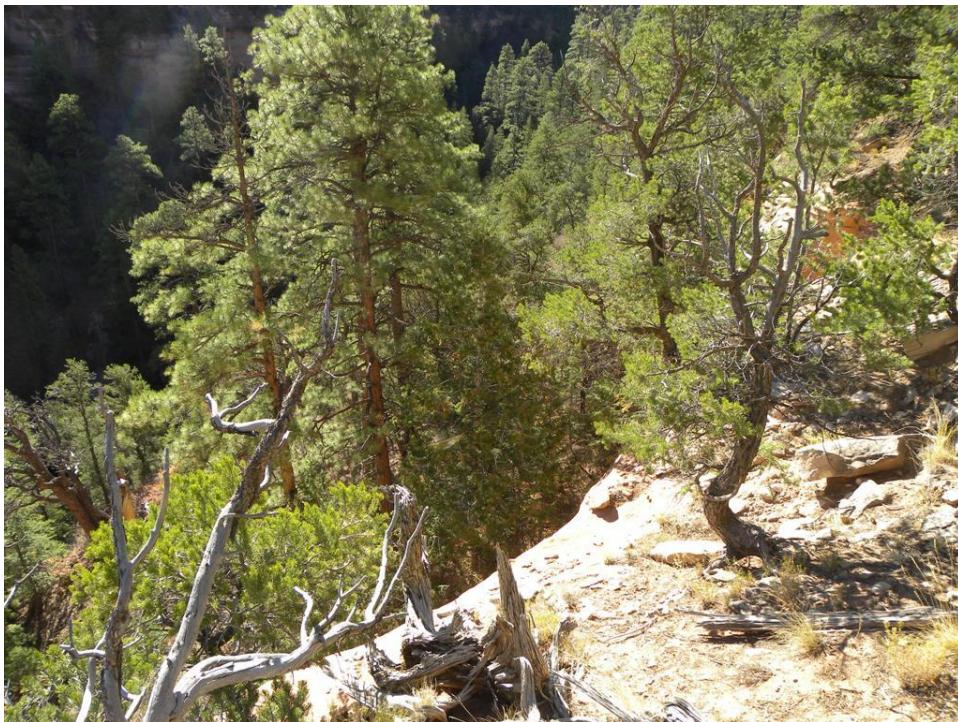
Photo 4. Mine site cliff area

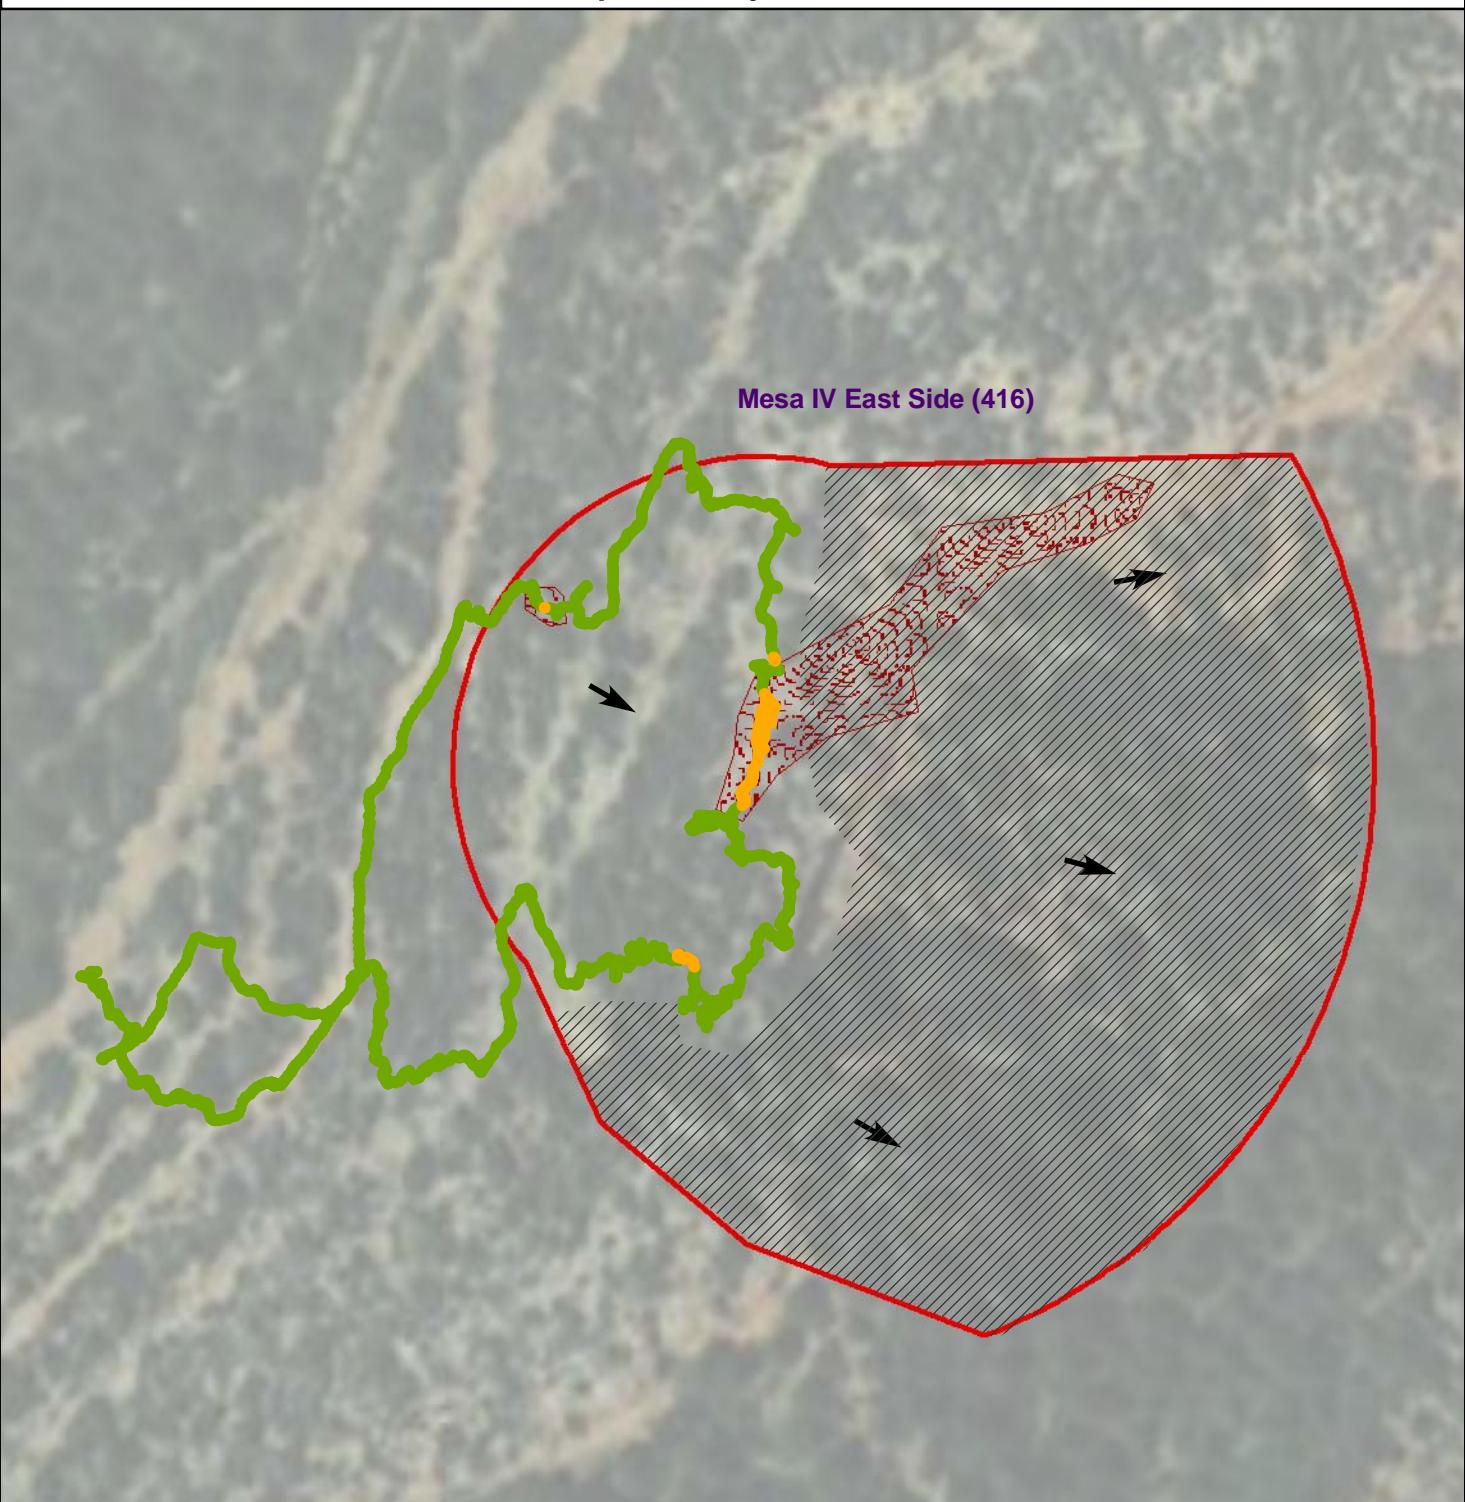
A total of 2,275 gamma radiation measurements were collected from the mine site, ranging from 6,520 cpm to 119,566 cpm. Measurements in the vicinity of the western waste debris pile were found at levels above 20,000 cpm, and at the northern pile above 100,000 cpm.. The measurements are represented in Figures 1 and 2.

Figure 1 - Gamma Radiation Measurements, Above Two Times Background
Mesa IV East Side (416)
Cove Chapter, Navajo Nation, Arizona

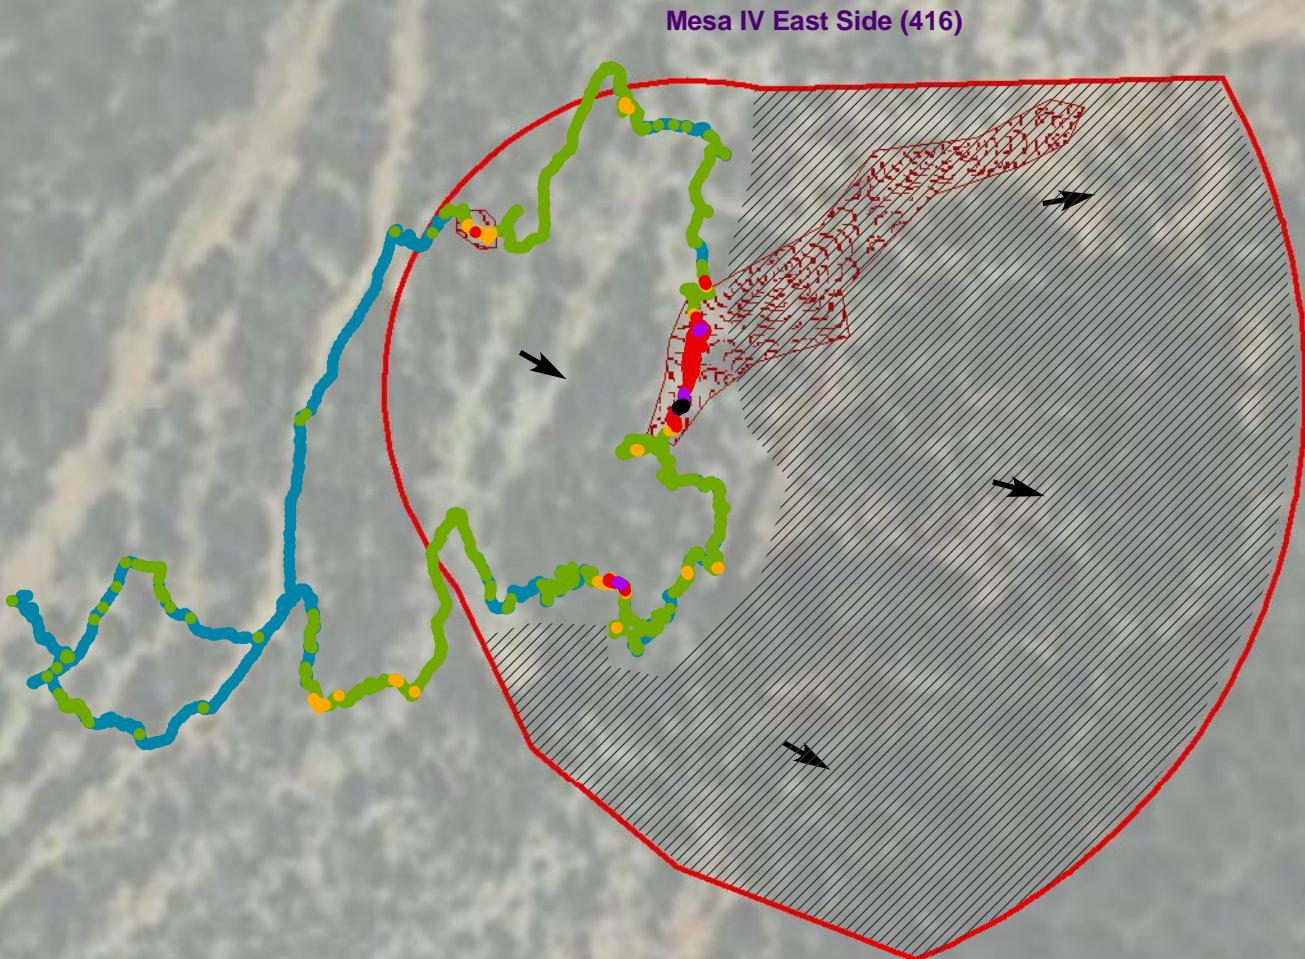
Figure 2 - Gamma Radiation Measurements
Mesa IV East Side (416)
Cove Chapter, Navajo Nation, Arizona
